*One man's pain is another man's gain.*

*An unfortunate thing happened to TCSZ 464544 in South Bethlehem around the beginning of October, 2010. Apparently the engineer was a bit too enthusiastic as he backed into the waiting RoadRailer train. The impact crumpled the leading van. Evidence remaining later in the week suggested the wreck was dismembered by reciprocating saw and then moved to the side.*

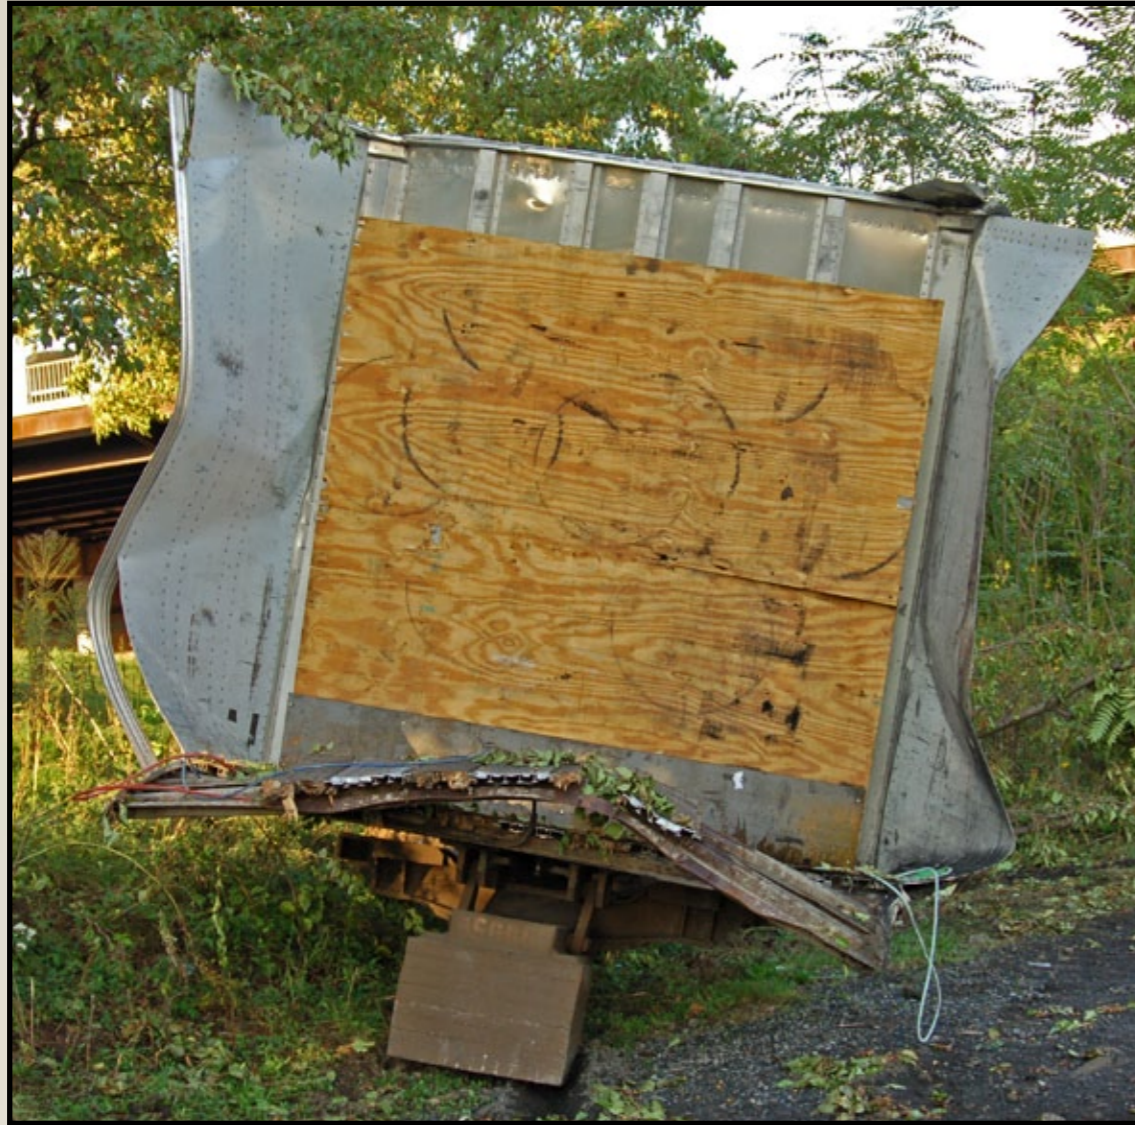
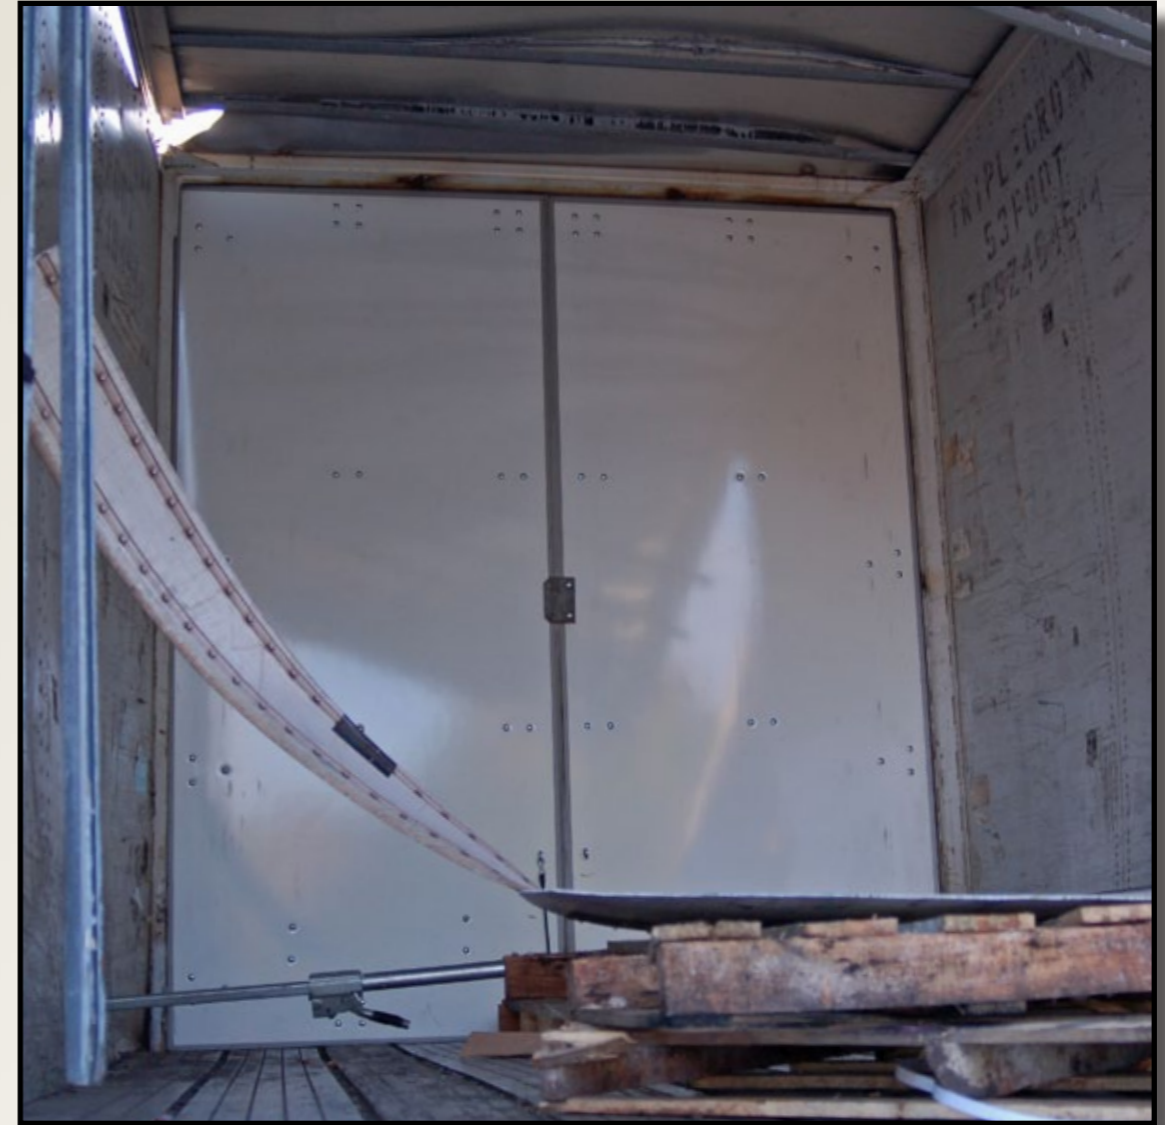
*Although this was an expensive accident for the railroad, it allowed views of RoadRailer construction that would be difficult or impossible to achieve otherwise. Inside views of both ends are shown here. Note the interior lettering just to the upper right of the doors and the carlines that support the thin aluminum roof. The sides have external posts and the front end has interior posts. The body of the CouplerMate was left attached to the front of the trailer.*

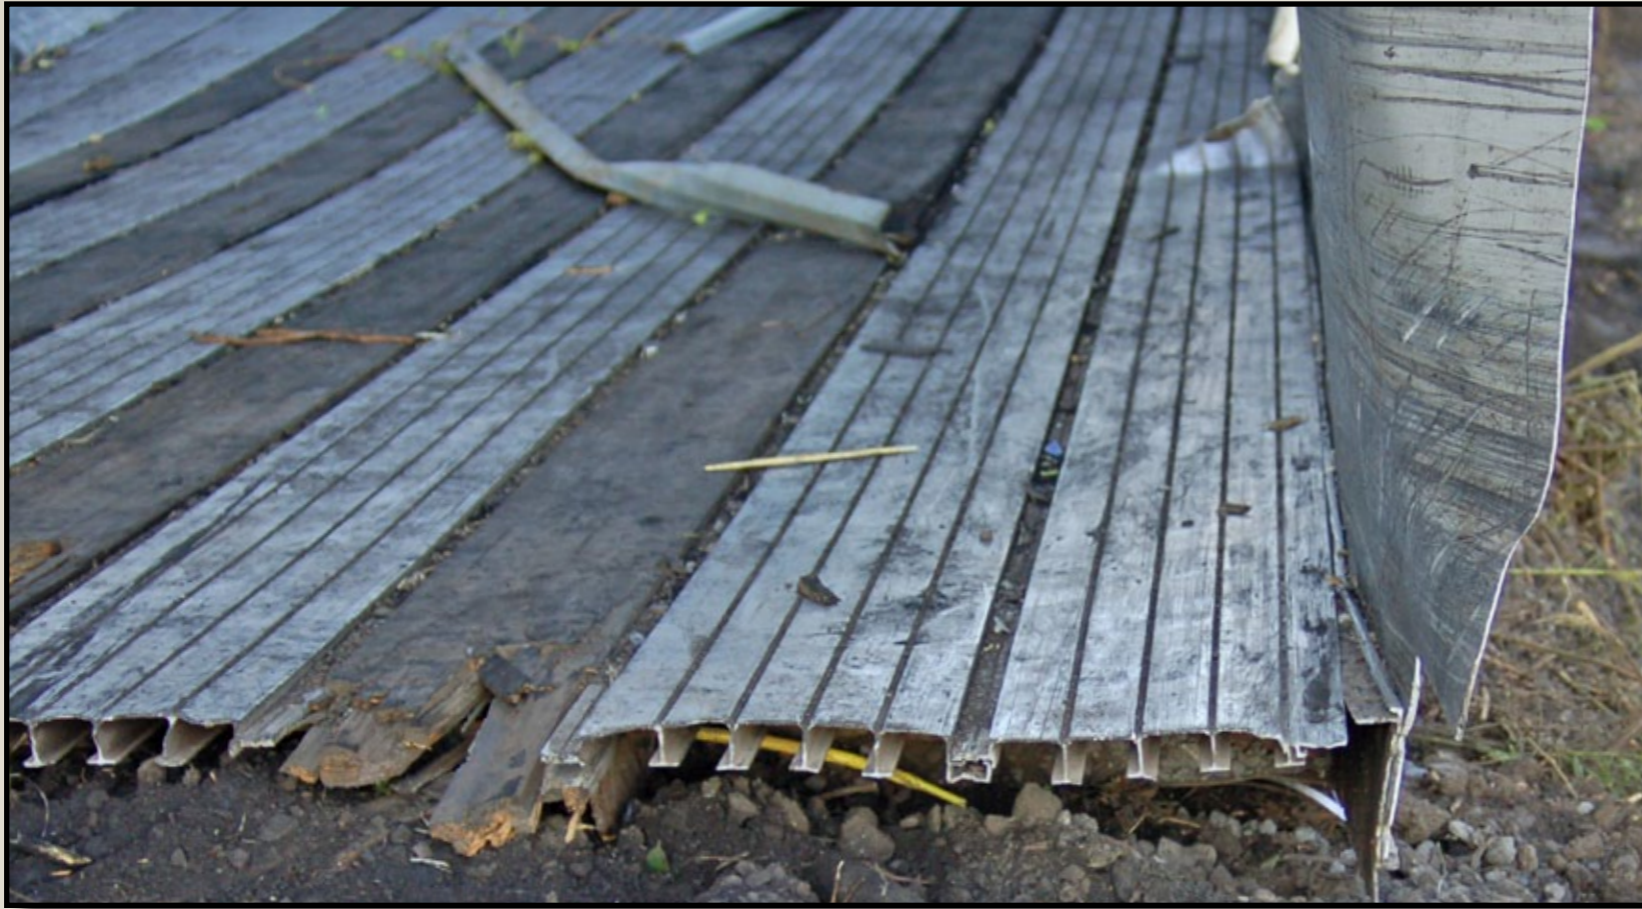
*A cross section of the composite flooring is shown above. RoadRailers use complex aluminum extrusions for the floor and side plates.*

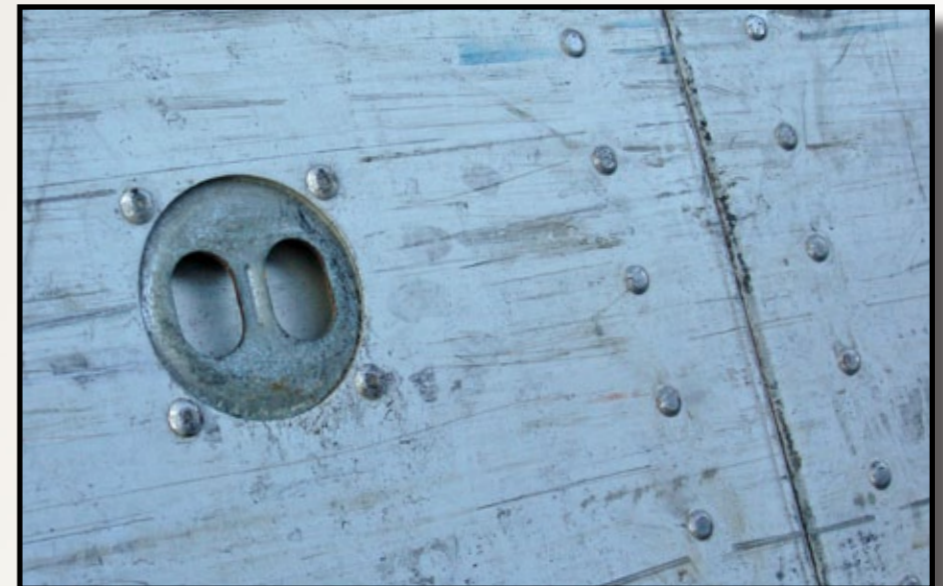
*The view on the right shows the tie down inside one of the many cups visible on the outside of the trailer. The side sheet splice hidden behind some of the outside posts is also visible.*
